Analysis and Recommendations for Street Network

Silver Creek

October 2016

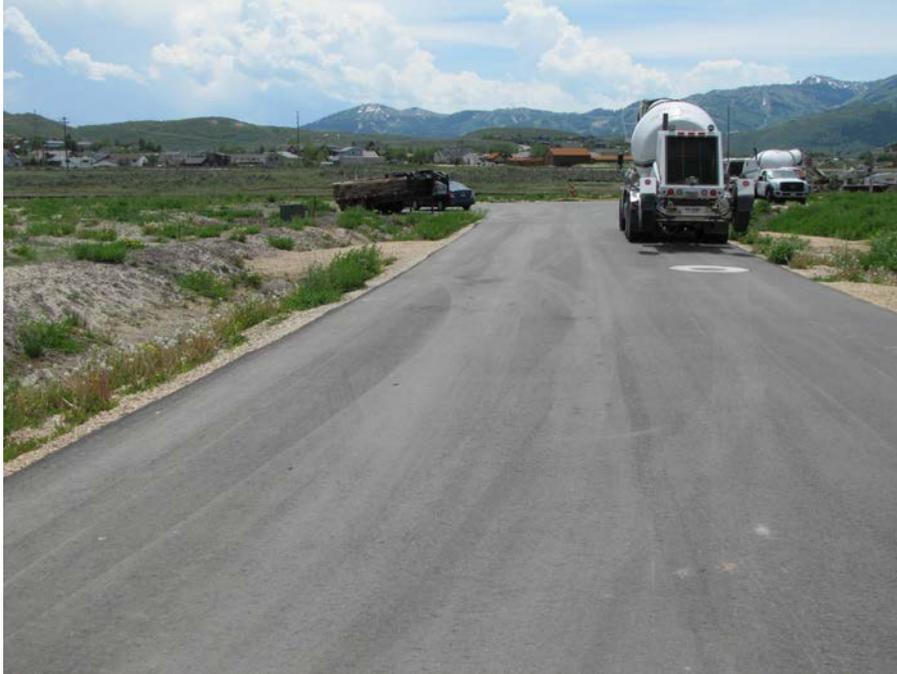
Visual condition surveys were calculated to evaluate pavement surface drainage conditions. If a newly-constructed road had a cross-slope of at least two percent (2%) or more, and provision was made for surface water to drain (e.g., well-graded ditches, curb and gutter, drainage structures, or paved ditches); surface drainage was rated as excellent. In the case that the road was not newly constructed but otherwise met the preceding criteria then it received a surface drainage rating of good. When the pavement cross-slope varied below two percent (2%), evidence of surface water ponding was observed, or the surface drainage features were not well maintained; surface drainage conditions were rated as fair. A poor surface drainage rating was given if the pavement cross-slope was flat or directed toward the centerline of the street, if surface water ponding was observed, or drainage provisions were not maintained or provided. The following three photographs illustrate excellent, good, and fair ratings, respectively.

Photo 1. Excellent Surface Drainage (Rae Circle from Greenfield Drive to Dead End)

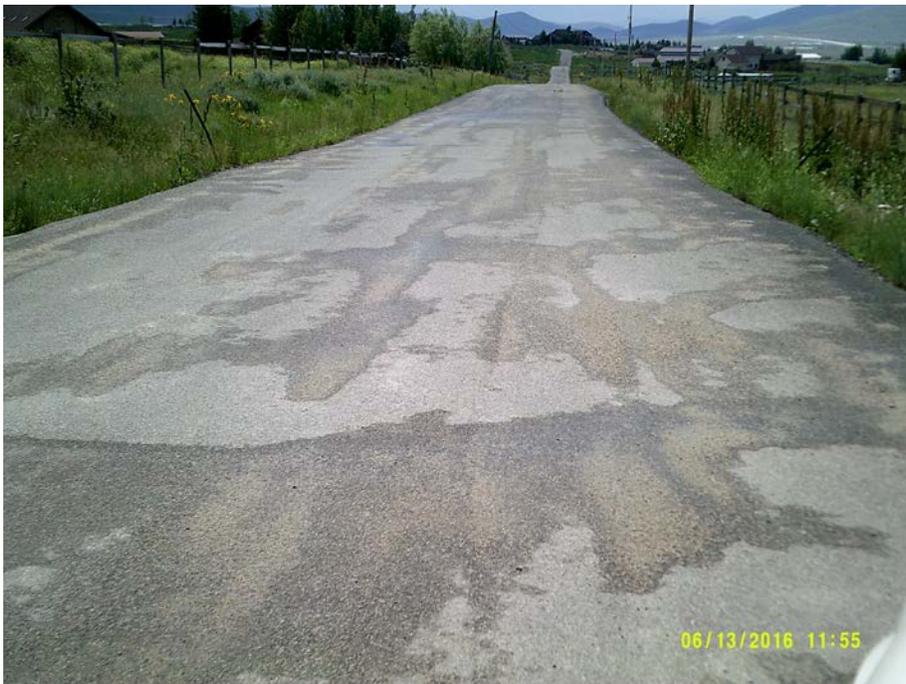
Photo 2. Good Surface Drainage (Meadowview Road from Redden Road to Silver Creek Road)

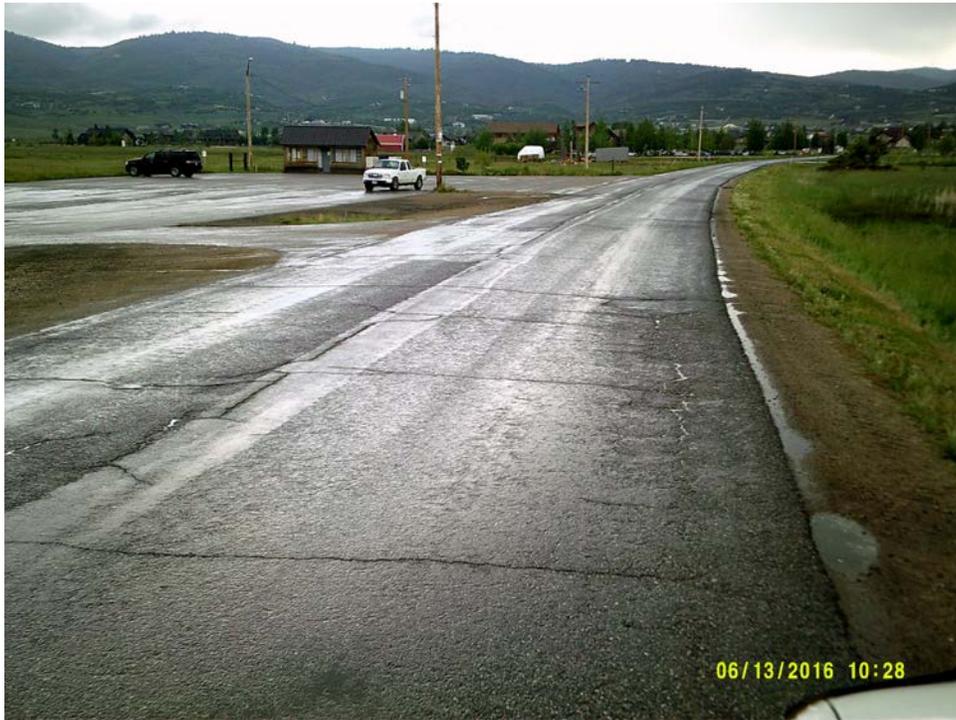
Photo 3. Fair Surface Drainage (Silver Creek Road from Valley Drive to Wasatch Way)

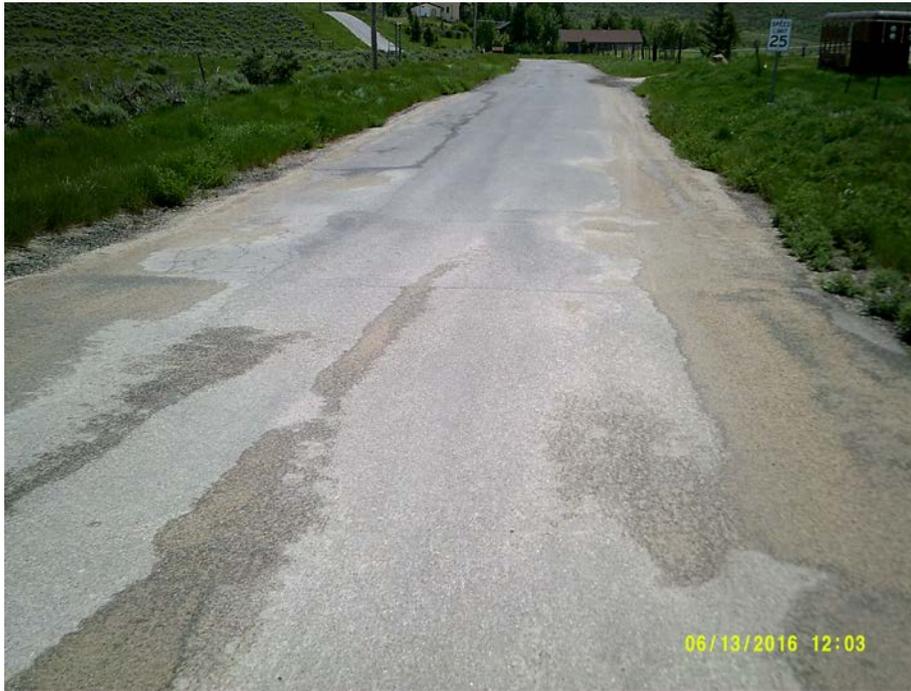
**Photo 4. Poor Condition – Crescent North from Silver Creek Rd to the End of Pavement
(RSL = 6 years)**

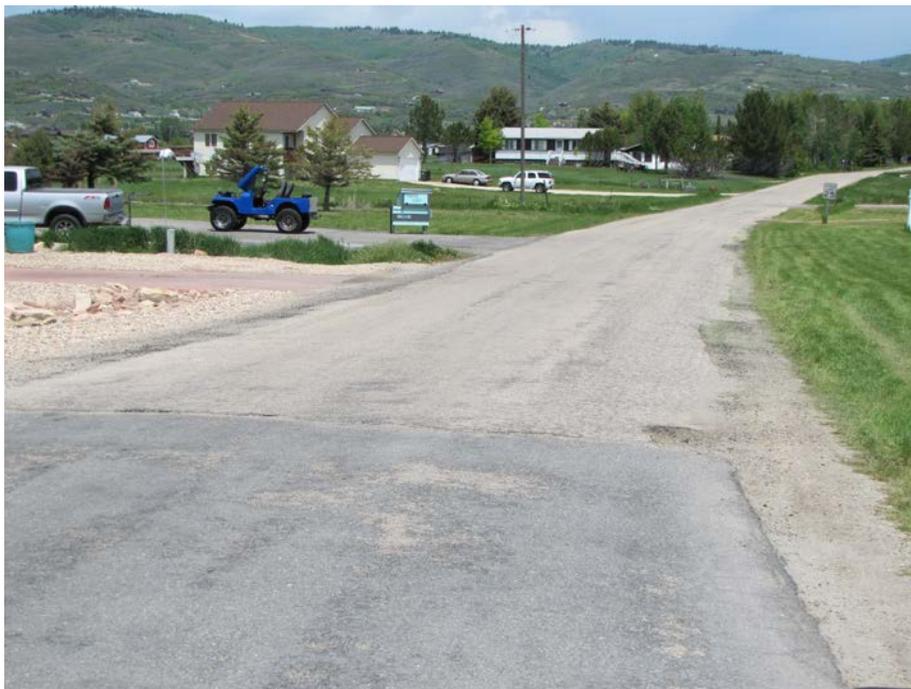
Photo 5. Fair Condition – Whileaway Rd from Parkway Dr to Wasatch Ln (RSL = 8 years)

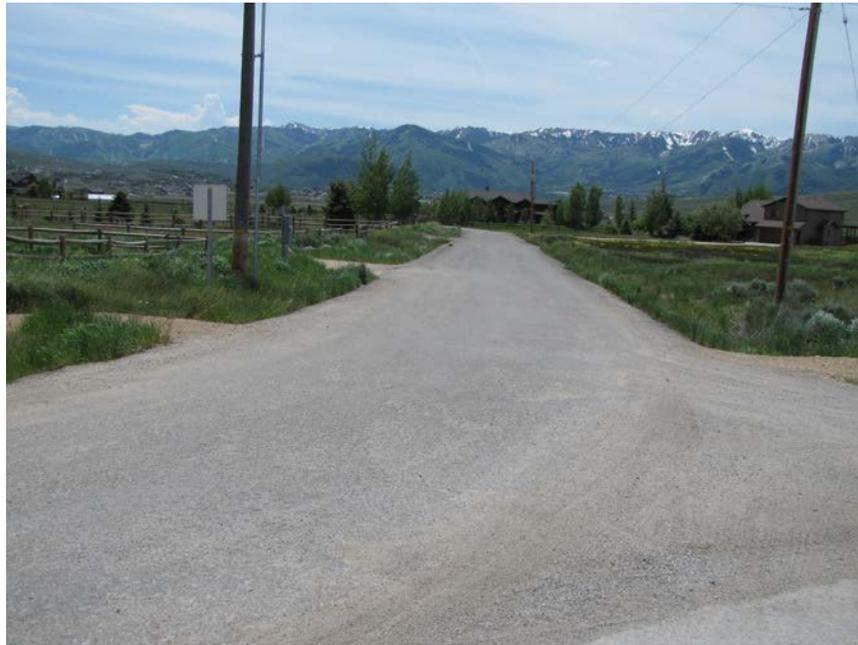
**Photo 6. Good Condition – Greenfield Drive from Wasatach Way to the Dead End Sign
(RSL = 10 years)**

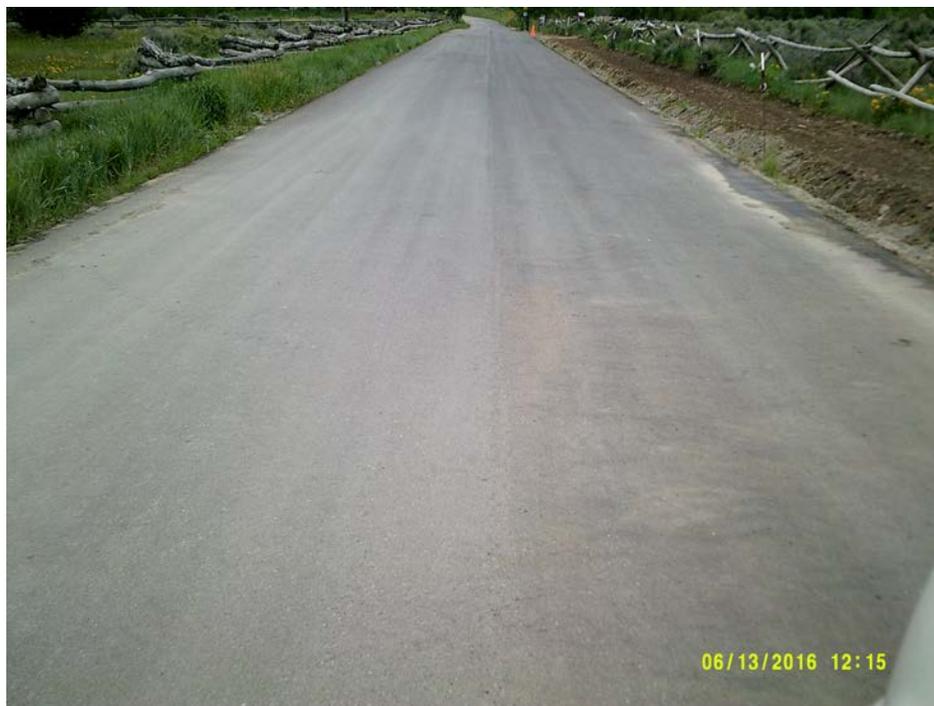
**Photo 7. Excellent Condition – Westwood Rd from Redden Rd to Cottonwood Trail Rd
(RSL = 20 years)**
